# ENGINEERING REPORT

## ANASTASIA'S POOL

4 Feb 2014

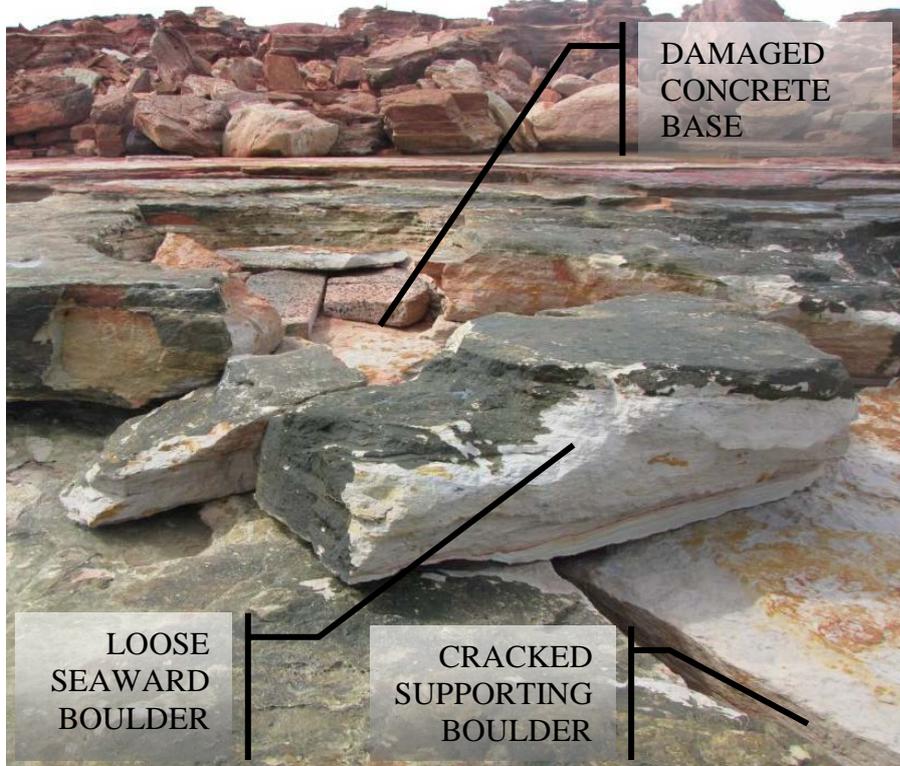
21 January 2014 (Courtesy DPaW). Anastasia's Pool as viewed towards the land. The large boulder in the foreground once formed the seaward wall of Anastasia's Pool. Concrete to the base of Anastasia's

Pool shows signs of loss of structure. Note the large vertical crack underneath this boulder, in the supporting rock platform.

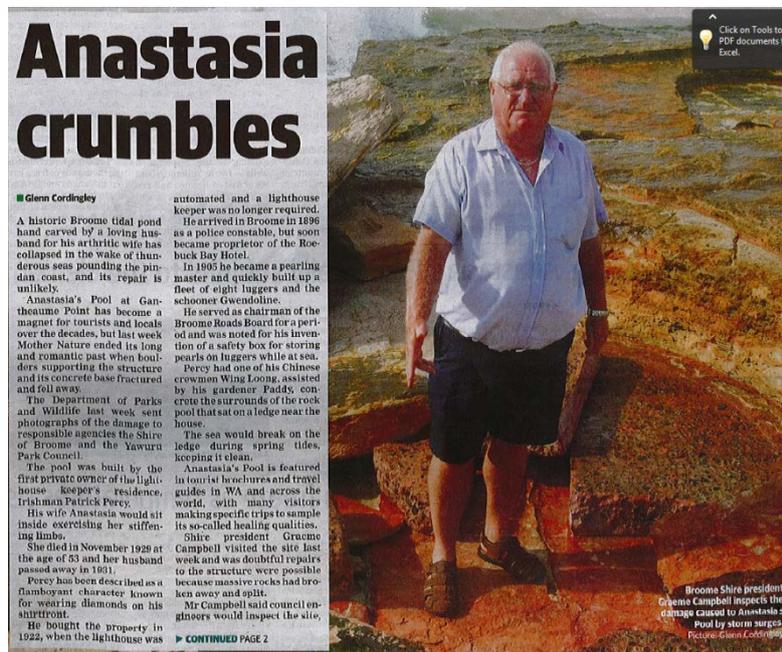
On 30 January 2014, the Broome Advertiser reported on the break up of Anastasia's Pool. The front page featured a picture of the Shire president standing adjacent to the remains of a portion of the concrete floor.

Front Cover of Broome Advertiser, 30 Jan 2014.

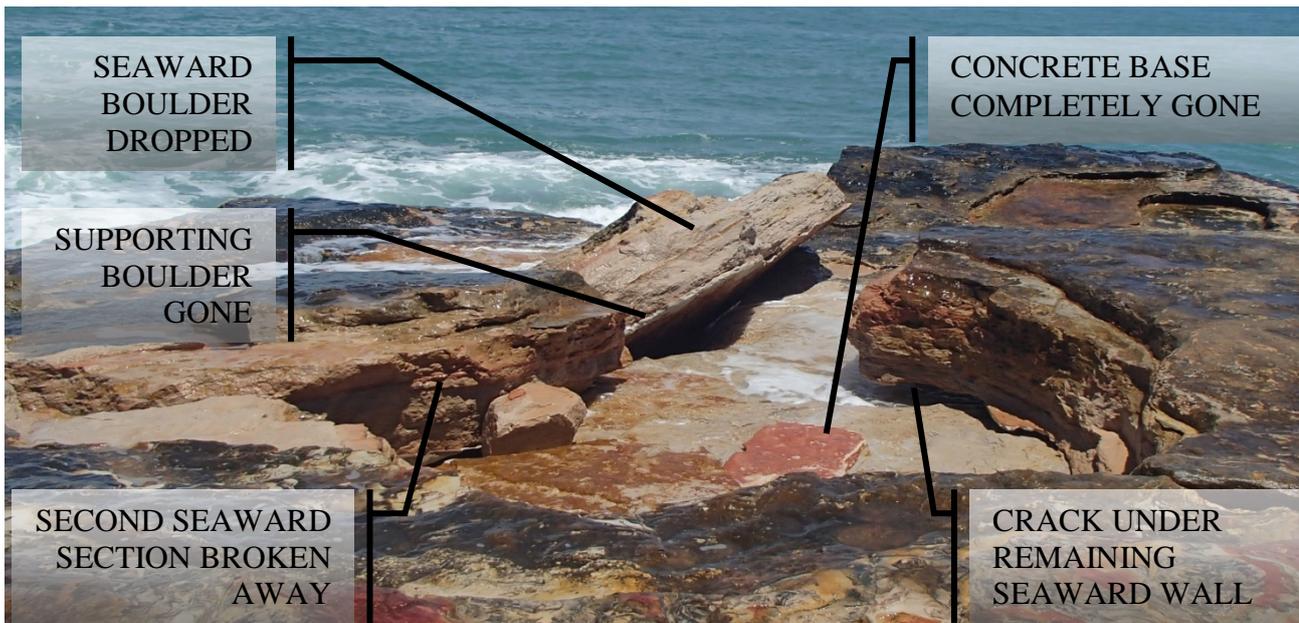
On the high tide of the 31 January 2014 an inspection of Anastasia's pool was undertaken by staff from the Shire's Engineering Department. More than half of the seaward side rock wall had been extensively damaged. The sandstone rock had broken into two pieces, each at least 5t in mass. Rock underneath these pieces had also disappeared, allowing one of the pieces forming the seaward wall of Anastasia's pool to drop and rotate away from the pool. There is no longer any concrete in the base of Anastasia's pool.

**31 January 2014. Anastasia's Pool, viewed toward the sea. The concrete base, which was visibly damaged in the picture on the 21st January 2014 is now is no longer evident at all. The supporting boulder has disappeared, with the result that the seaward boulder has now dropped. A second seaward section of rock has also broken away. The remaining seaward side of Anastasia's Pool has a large crack at the wall/floor interface.**

**There is now very little left of Anastasia's Pool to preserve.** The concrete base has been completely washed out of Anastasia's pool. A significant portion of the ledge underlying the structure has broken away. Almost the entire seaward rock wall has been broken up into two main pieces. The remaining section of seaward facing wall has cracking at the base/wall interface.

**Anastasia's Pool cannot be repaired.** The seaward wall of the pool has broken up into two large boulders and the supporting substrata has disappeared. The repair methodology outlined above would not be in keeping with and demean the heritage and cultural significance of Anastasia's Pool and the surrounding natural beauty of the point.

**Provide Signage to identify Anastasia's Pool for future visitors.** This outcome would have to be in keeping with the existing visitor information themes at Gantheaume Point.
