# ENGINEERING REPORT

## ANASTASIA'S POOL

4 Feb 2014

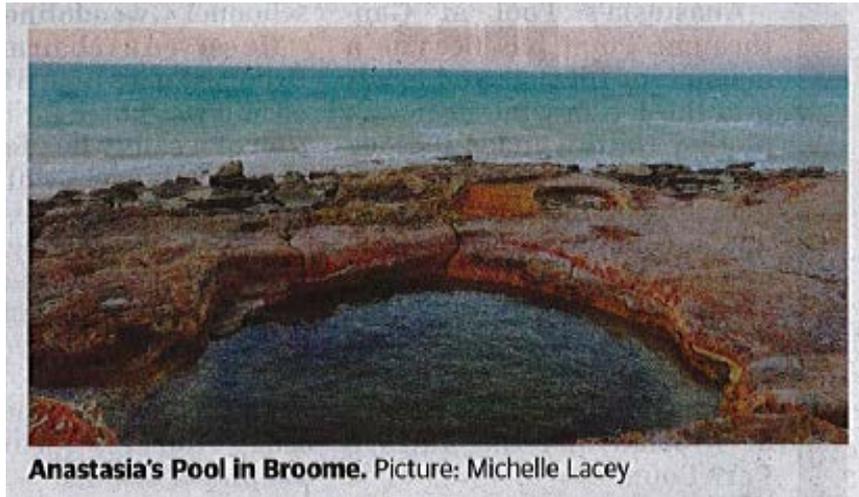
Anastasia's Pool in Broome. Picture: Michelle Lacey

An earlier photo of Anastasia's Pool as appeared in the Broome Advertiser, 30 January 2014.
